Experimental Evaluation of Seismic Residual Performance for Deteriorated Rubber Bearings in Highway Bridges

KEYWORDS: Rubber bearing, Aging deterioration, Seismic residual performance

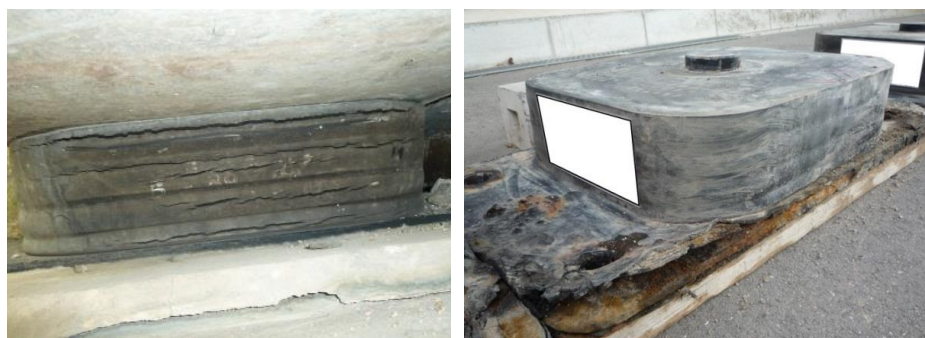
The bearings had been used in service for 27 years. As can be seen in Figure 2.2, surface cracks appear on the bearings because of aging deterioration of the rubber material over time. Moreover, the bottom plate suffered partial corrosion due to water leaked through the expansion joint.

Figure 2.2 Damage status and cracks of ring bearings

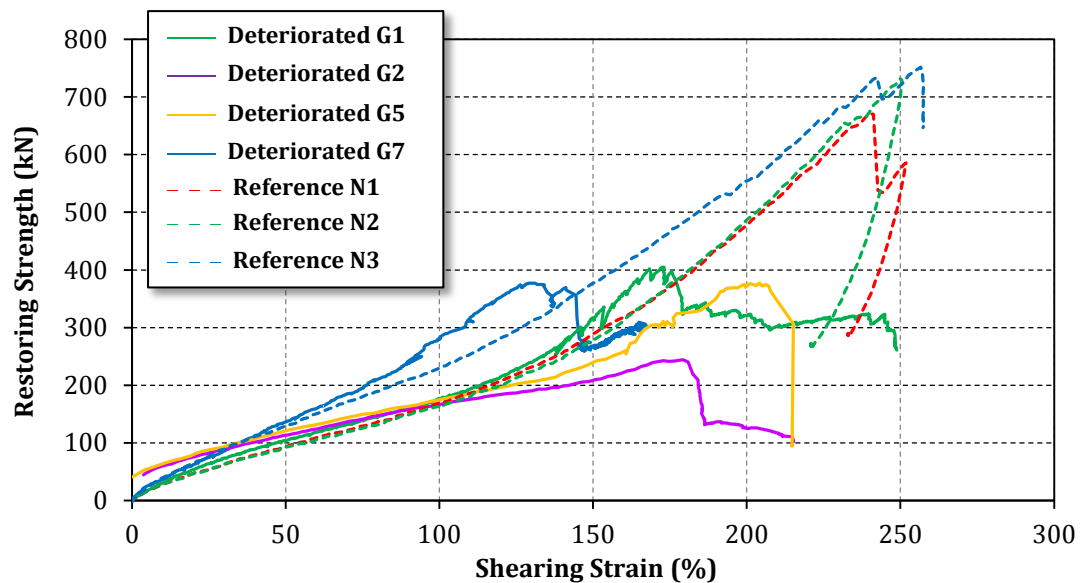
The restoring force curves obtained by the UD tests are shown in Figure 3.2. The reference sample bearings failed at 240% strain on average, satisfying the allowable shear strain requirement of 150%, although G7 failed at 131% strain. On the other hand, the failure of G1, G2 and G5 took place at shear strains exceeding 150%. Possible reasons for the variation in the failure strain among the samples include the difference in the progress of aging deterioration caused by environmental conditions in service period, manufacturing process or interaction between those factors.

Furthermore, the maximum restoring force of the four deteriorated bearings was 40% less than that of the reference bearing. Since the most influential factor to the load capacity degradation was inferred to be the aging deterioration, several supplemental tests had been conducted in order to evaluate the influence of the deterioration.

Figure 3.2 Result of UD tests

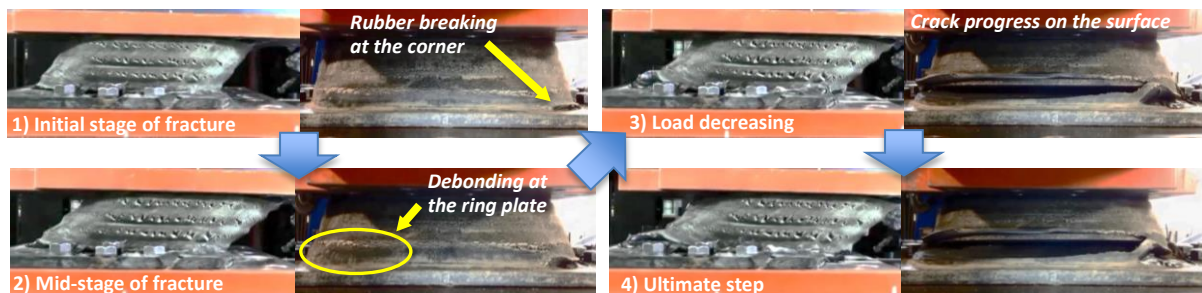
The onset of fracture and its progress were analyzed by the video image of the UD tests. The images of the G7 test are shown in Figure 3.3. Debonding began from the ring plate, followed by a gradual progress of cracking extended to the bearing surface, and then the ultimate state was reached. The fracture was induced along the boundary between the bottom plate and rubber. The process of fracture forming is identical for all the deteriorated bearing samples. On the other hand, the fracture forming in the reference bearings is different from this description. The fracture was induced within the rubber layer between lower ring plates as commonly assumed in the design of bearings.

Although many ozone cracks are generated in ring bearings during the regular service, any extension and growth of these cracks that cause fracture of rubber layers were not observed in the tests. Therefore, ozone cracks on the surface of the bearings are not considered to be a critical factor that affects the seismic performance or bearing fracture process.

Figure 3.3 Video capture of UD test in G7

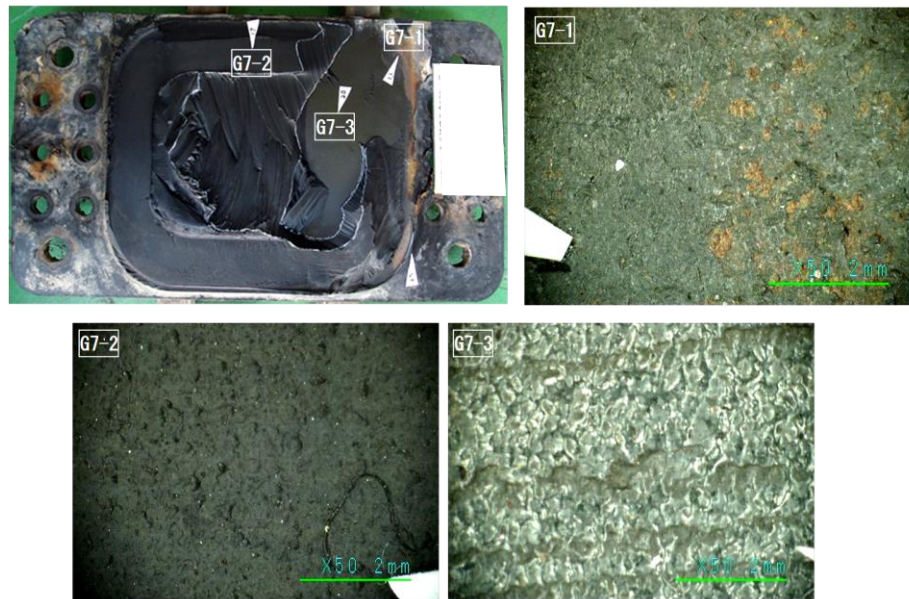
The fracture surfaces after the UD test were observed using microscope to explore the fracture mechanism. In general, several fracture patterns corresponding to the fracture mechanism of rubber are known, and the periodic striations associated with shear failure are typically observed. Figure 3.4 shows the fracture surface of the bearing sample G7 formed between the bottom plate and rubber layer. The image G7-1 was obtained on the outer edge of bearing involving rusted spots, image G7-2 was taken on the rubber side of the ring plate showing an almost flat fracture surface, and image G7-3 was observed on the surface of bottom plate having emerged due to the debonding between the bottom plate and rubber. The striation pattern is not found in those fracture surface images, including the other deteriorated bearing samples. This observation strongly suggests that the fracture in deteriorated bearings takes place on the area of adhesion between the steel plate and rubber.

Figure 3.4 Fracture surface of G7

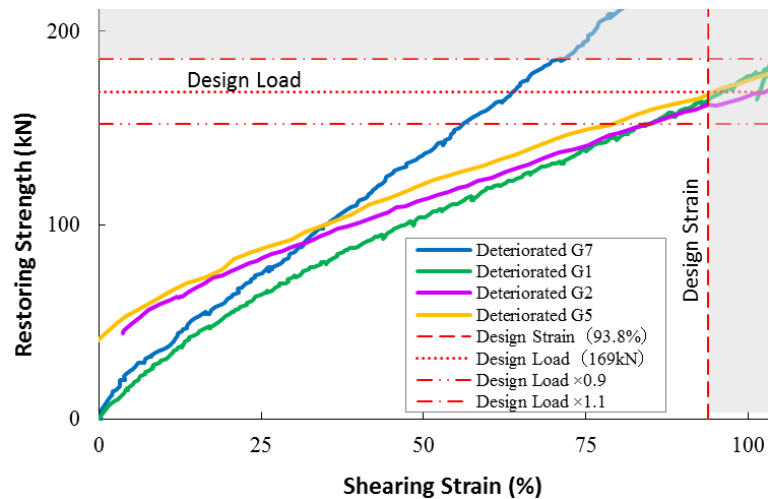
Figure 4.1 Design values and result of UD tests

Figure 4.1 shows the result of the UD tests in comparison with the design values. The strength of all deteriorated bearings exceeded the design load of 169kN, and the restoring forces at the design strain (93.8%) are found to be almost equivalent to the design load with a factor between 0.9 and 1.1, with the exception of G7. Therefore, the seismic residual performance of the deteriorated bearings is almost satisfactory with respect to the requirement for the Level 1 Earthquake. However, requirements for the Level 2 Earthquake (MCE) in the current seismic design specifications are yet to be investigated.
