Fatigue Behavior of Multi-scale Recycled Aggregate Reinforced Concrete

Hui-Qun Yan^{1,2,3}, Jiann-Wen Woody JU³, Qing-Yuan Wang^{1,2}

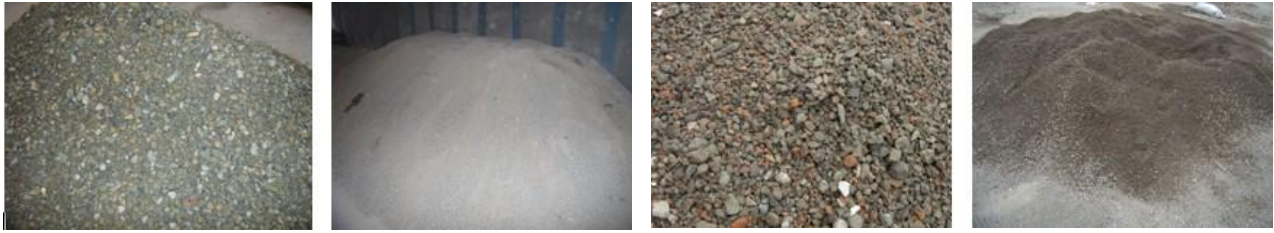
a) gravel
b) river sand
Figure 1 Photographs of the coarse and fine natural

The natural coarse aggregate and fine aggregate used were gravel and river sand. The diameter of the gravel was 5~31.5 mm, and the maximum size of the river sand was around 2.36 mm (Fig.1).

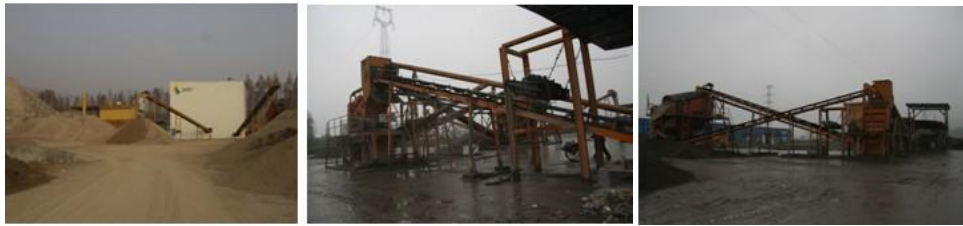
Fig. 2 Photographs of the recycling facility

The recycled concrete aggregate was obtained from the DuJiangYan, China area, one of the 512 earthquake disaster area. The recycling facility processes mainly concrete rubble sourced from demolition projects by crushing and sieving (Fig. 2). The crushed concrete rubble was processed to pass through a mechanical sieving system to produce coarse recycled aggregate (Figure. 3). The diameter of the aggregate was 5~31.5 mm, and was mainly divided into sizes 5~15mm and 15~31.5mm. In the experiment, the quality ratio of the 5~15mm to the 15~31.5mm aggregate was 3:2, and this ratio was used throughout the investigation.

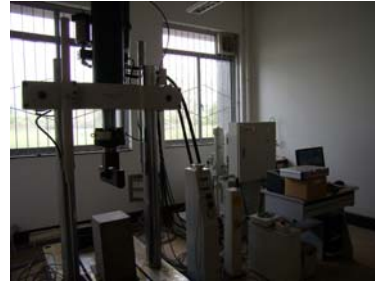
Figure 5 Shimadzu EHF-UM/UV servo-fatigue Experimental Machine

A 4890 fatigue experimental machine (EHF-UM/UV servo-fatigue experimental machine) made by Shimadzu in Japan (as Fig.5) was used, and a YAW-5000 compressive experimental machine was employed for compressive strength experiments, load capacity of 5000KN.

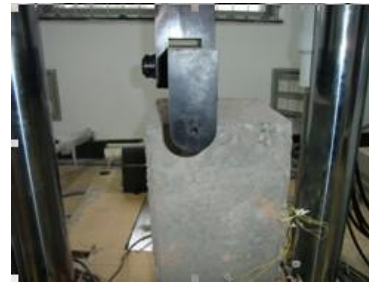
(b) Top view of load actual position

Figure.6 Load positions of tests

In the Shimadzu EHF-UM/UV servo-fatigue experimental machine, fatigue load is varied from 110kN~190kN at 5Hz frequency, and the static load was from 0 to 150kN, and then uninstalled, in steps of 30kN. The location of the load is axial or eccentric ($e=65\text{mm}$). The modeling and actual load positions are shown in Fig. 6.

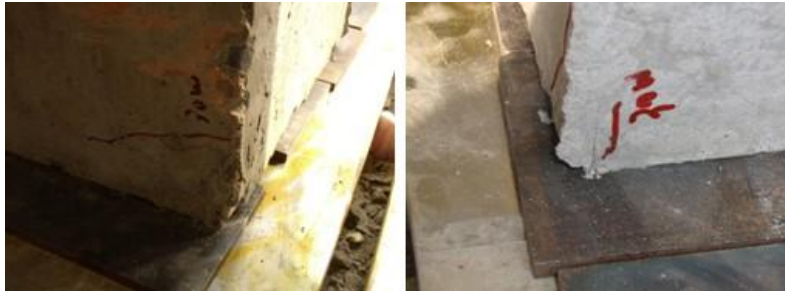
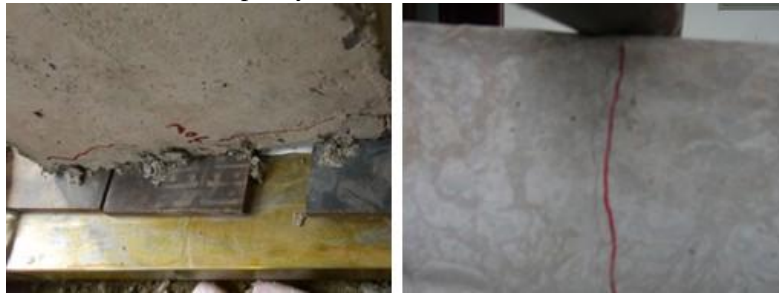
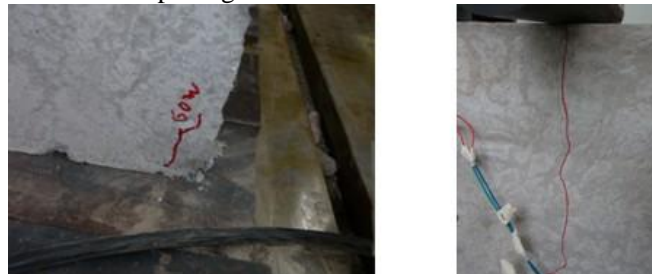
(a) horizontal crack and pastry at bottom (b) vertical crack at bottom

(c) horizontal crack and spalling at bottom (d) vertical crack at contact surface

(e) vertical crack at bottom (60w cycles) (f) expansion of vertical crack at the contact surface (60w cycles)

Figure 8 The position and extension of the cracks after axial fatigue loading

After axial compression, the fatigue behaviour of each replacement proportion specimen was similar. At first, there was no obvious change in the squeezed static load, but when the fatigue load had reached about 3×10^5 cycle, cracks were generated at two places, one on the bottom of the specimen and another on the contact position with the test machine. At the bottom angle region of the specimen, there were vertical and horizontal small cracks, but not substantially expanded, and accompanied with the pastry and broken (as Fig.8 (a) - (c)); there were some longitudinal cracks on the contact surface of the test machine (as Fig. 8 (d)). After the first

fatigue loading, the development of the cracks were very small (as Fig. 8 (E), (f)). After, continuing with the fatigue experiments, there were no fractures even up to approximately 10^7 cycles.

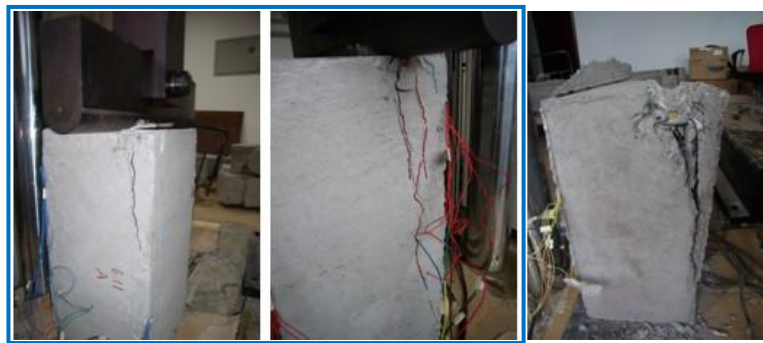
(a) horizontal crack and spalling at bottom (b) vertical crack at contact surface

(c) extension of the vertical crack (d) fracture of specimen

Figure 9 The position and extension of the cracks under eccentric fatigue loading

For the first static load, a few fine cracks appeared on the specimen, and the crack growth was very slow as the force was applied. After the first fatigue loads, the fine cracks gradually increased, extended, and accumulated especially those that could be seen in the vertical crack, at the contact surface of the machine. Generally, specimen failure due to these vertical cracks occurred at lower cycles, and was accompanied with a loud noise. The damage of the specimen was sudden, without warning (as Fig. 9)!

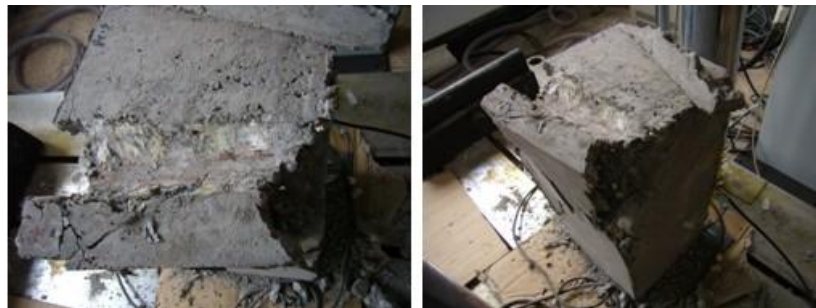
(a) (b)

Figure 10 Fracture of the section

Moreover, the clear fractured zone was indicated on the RAC specimens. Fig. 10 shows that there were different interface roughness regions on the fracture surface. The fatigue source zone was in the cracks generated by the contact surface; in which, the two face parts of these cracks rubbed and deformed repeatedly together, thus making smooth regions on the fracture surface. These areas are called the expansion area. The fracture area was the roughest of the damage areas, caused by gradually expanding the cracks due to the
