Shaking Table Tests on Collapse Patterns of Eight Different Multi-Storey with Different Structures

J.W. DAI¹, Y.Q. YANG², R.C. SHAN³, S. CUI³

KEYWORDS: *shaking table test, collapse pattern, RC frame structure, masonry building, bottom RC frame*

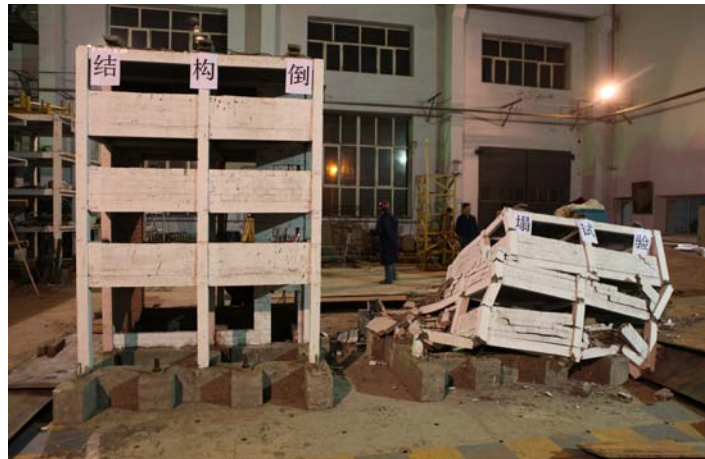
Viewed from the holistic damage condition of the models, damage at the end of frame columns of model A was obviously more serious than the damage of model B. Especially under a large PGA, the difference of failure modes between two models was bigger and bigger. Although frame columns’ damage was more serious than frame beams’ eventually of two models, the number of plastic hinge of beam in model B is far more than the number in model A. Ductility of Model B structure was well. Finally, model A collapsed, in stark contrast, while model B was not completely destroyed, as shown in figure 2.2.

Figure 2.2 Destruction condition (Left one is model B, right one is model A)

All in all, the limited disconnection measure between the floor slabs and the ends of beams changed the failure pattern of frame structures, effectively delayed the destruction of frame columns and improved the ability of deformation of frame structures. It is of benefit to achieve the fortification goal of "no collapse in strong

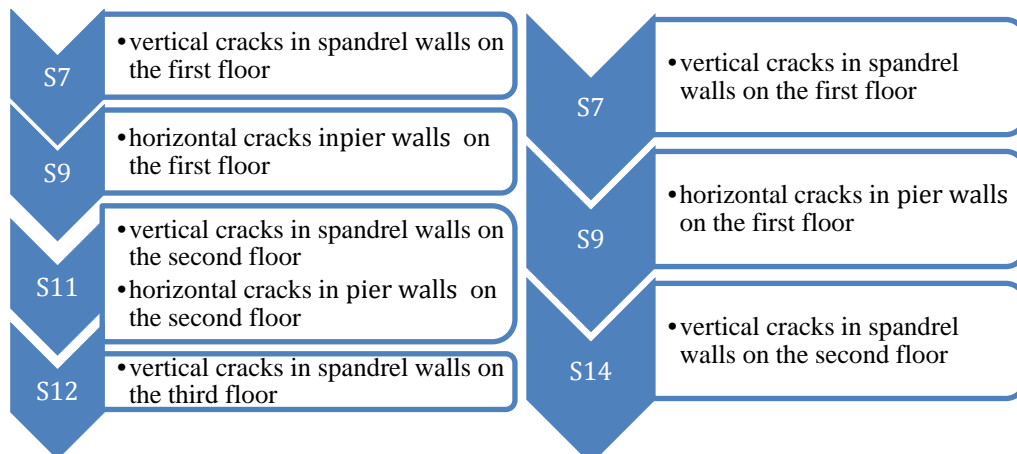
Figure 3.4 Destruction process of external longitudinal walls of model D in axis A (left) and axis C (right)

It can be seen that, pier walls were failure first and then spandrel wall were failure in the model C. Its failure pattern was similar to the "strong beam weak column". While in the model D, spandrel walls were failure first and then pier walls were failure. Spandrel walls fully absorbed the seismic energy, which was benefit to improve the collapse resistant capacity of the structure. Its failure pattern was similar to the "strong column weak beam". Therefore, this test showed that the failure pattern and aseismic capability of masonry structure can be improved significantly by controlling the stiffness ratio of pier/spandrel walls.

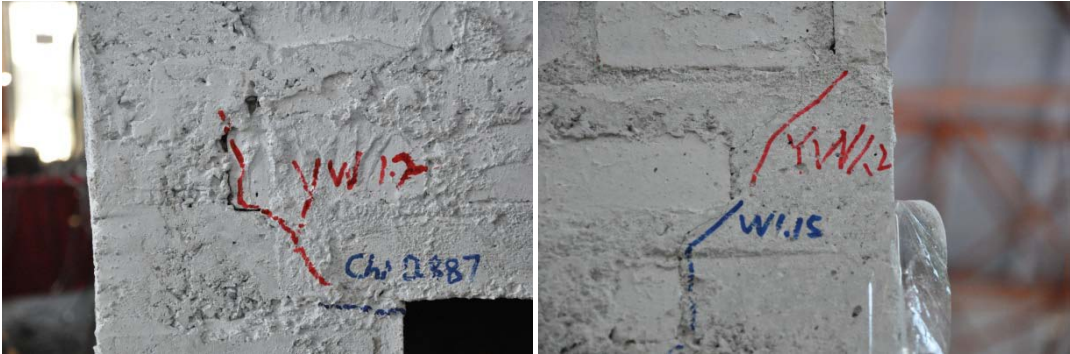
During the whole test, the cracks of model E were slight in small earthquake action, but they were increased developed obviously in the large earthquake action. Horizontal cracks on the pier walls and diagonal cracks on the window corners were most, and the latter ones developed obviously. Although the cracks of model F were more obvious than model E in small earthquake action, but with the increasing of input ground motion, the damage development of model F was slower than the model E.

a Diagonal crack at the corner of window in axis ① b Diagonal crack at the corner of window in axis ②
Figure 4.2 Destruction of model E

main failure phenomena. At the end of the load case, model E and F were not collapse. The main failure of model E was in the bottom layer. With the motion input increased, the damage developed from the bottom to the upper layers, as the bottom destroyed further and the second or third layers appeared obvious damage. The failure mode of model F was similar with that of model E. The bottom layer was heavily damaged, and the third layer was slightly damaged. The damage degree of model F was lower than the model E.

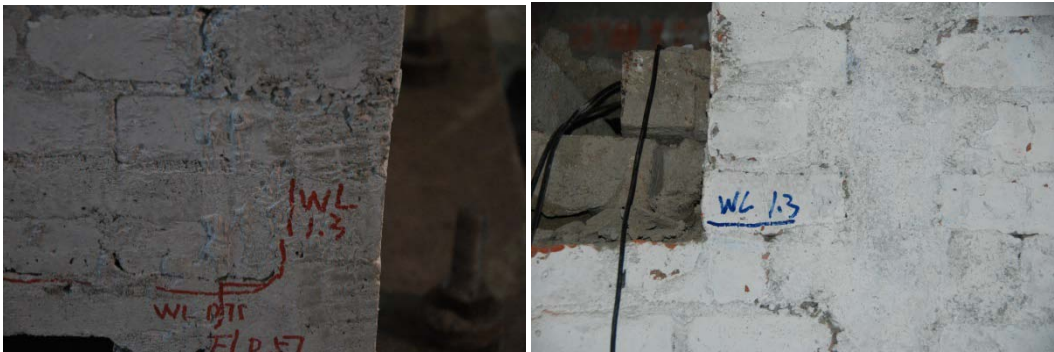
a Diagonal crack at the corner of window in axis ① b Diagonal crack at the corner of window in axis ②
Figure 4.3 Destruction of model F

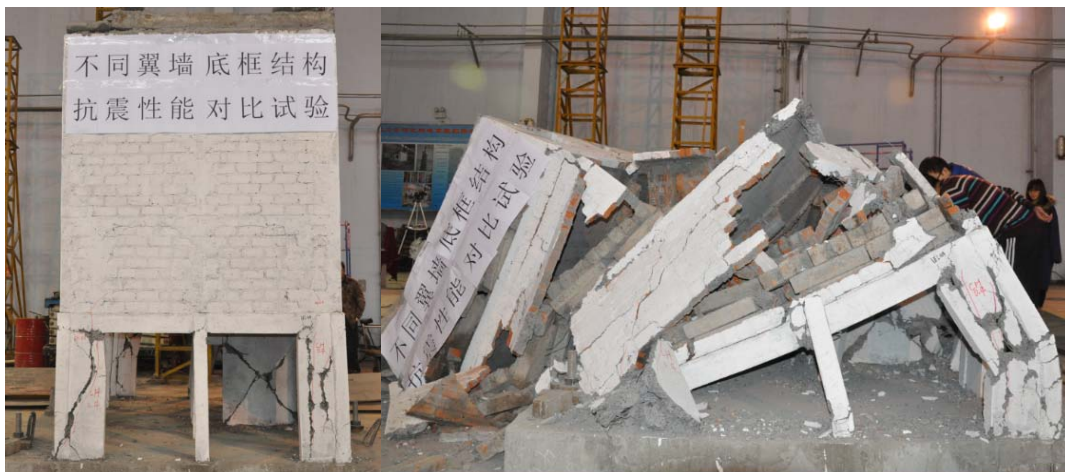
After the condition of T20, the frame storey of Model G damage seriously and mainly lost bearing capacity, but the masonry part was mainly intact. The shear walls in axial ⑦ appear “X” shear crack. Concretes at the end of frame columns on the side of axial A were all crushed, frame columns were unable to work. The shear wall in axial ① and axial ⑤ cracked completely and appeared a large inclination deformation. The destruction of framework storey in C axis was lighter than other parts. At the condition of T22, the frame columns on the side of axial A all could not work, the model occurred serious inclination deformation and collapse.

Figure 5.2 Destruction of model G after T20

Figure 5.3 Collapse of model G

The upper masonry structure of model G had few cracks, while the bottom frame structure was severely damaged. The stigma and pedestal cracked firstly indicates that the design of model G was not reasonable. Almost all the earthquake energy was absorbed by the ground floor. The upper masonry part of model H cracked firstly and then the bottom frame part followed. Although model H finally collapsed from the damage of ground floor, the upper part also took part in the earthquake resistance, absorbed lots of energy and enhanced the seismic capacity of the structure. The test result shows that adjusting the lateral stiffness ratio between the bottom frame part and the upper masonry part could enhance the seismic performance of bottom frame masonry structure.

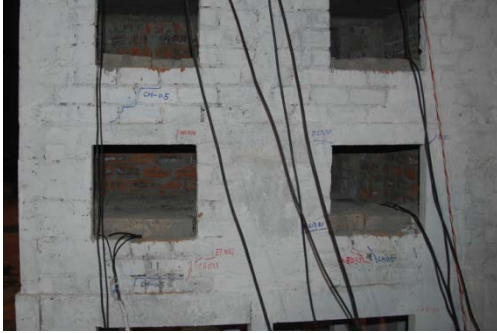
After the condition of T22, in the model H, the spandrel walls in axial A between axial ① and axial ③ on the second and the third floors appeared crack. The part in axial C between axial ④ and axial ⑤ on the first and the second floors began to appear fine crack. The overall destruction of the structure was lighter than moderate damage. After Model G collapsing, model H experienced additionally 6 times earthquakes (PGA>0.4g) and then collapsed, as shown in the figure 5.5.

Figure 5.4 Cracks on spandrel wall of model H

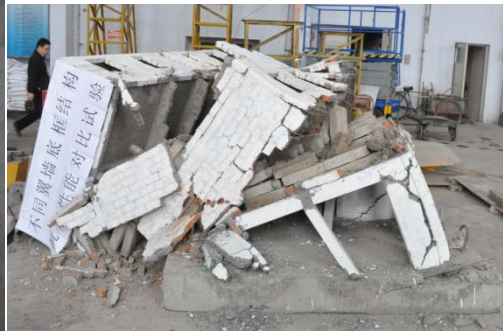
Figure 5.5 Collapse of model H
