Study on shear performance and residual shear strength of concrete members after fire

KEYWORDS: concrete structure, fire behavior, shear property, residual bearing capacity

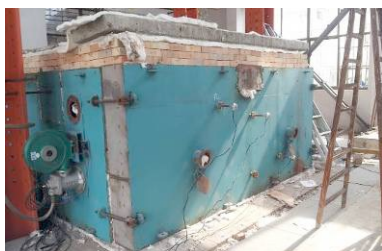
Figure 2.2 the furnace chamber

Temperature load is applied to all the specimens in a furnace chamber, as is shown in Figure 2.1. The surface of the slab is applied to 1 kN/ m² uniformly distributed load, as is shown in Figure 2.3. During fire tests water stains appeared one after another on the plate, as is shown in Figure 2.4 and Figure 2.5. After fire, concrete spalling was found at the bottom of the slab, steels were exposed, and there were a few cracks on the surface of the slab, as is shown in Figure 2.6 and Figure 2.7. Then static load test and Quasi - static tests were conducted. Figure 2.8 and Figure 2.9, respectively , shows the loading schematic for restrained beam and cantilever. Figure 2.10 shows the quasi-static test for fire-damaged concrete frames. Temperature was increased by the furnace according to ISO834 standard heating curve, Figure 2.11 shows a comparison between the ISO834 standard fire curve and the measured time-temperature curve in the furnace. Both the thermal and structural responses were measured during the tests and collected automatically by the computers.

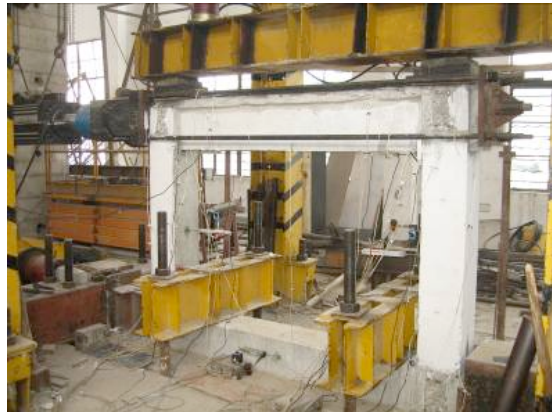
Figure 2.10 Quasi-static test for fire-damaged concrete frames

Two parameters were mainly considered in the quasi-static tests, including fire-damaged or not and the relative stiffness of beams and columns. Details of fire-damaged concrete frames are listed in Table 2.3.
