Experimental Evaluation of Seismic Residual Performance for Deteriorated Rubber Bearings in Highway Bridges

KEYWORDS: Rubber bearing, Aging deterioration, Seismic residual performance

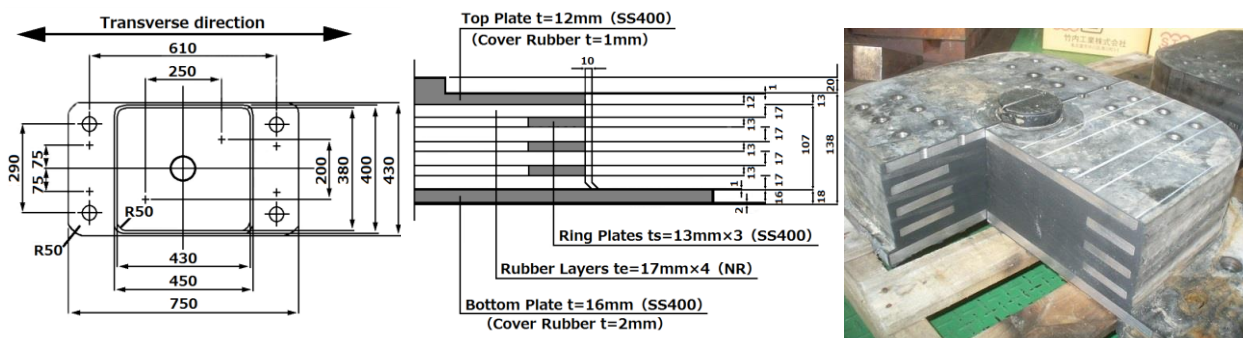
Figure 2.1 Dimensions of ring bearing samples

The elastomeric bearings for the experimental performance evaluation in this study were installed in 1986 and designed as seismic isolators to distribute the horizontal seismic force. Energy dissipation during seismic response is not expected in the design. The elastomeric bearings consist of four NR layers and steel ring plates, as shown in Figure 2.1. The plan dimensions are 400mm×450mm, the total thickness is 107mm with four rubber layers of 17mm thickness and three ring plates of 13mm thickness. The shape factors are $S_1=5.93$ and $S_2=3.55$. The elastic share modulus of the natural rubber material is 1.05N/mm^2 (G10.5).

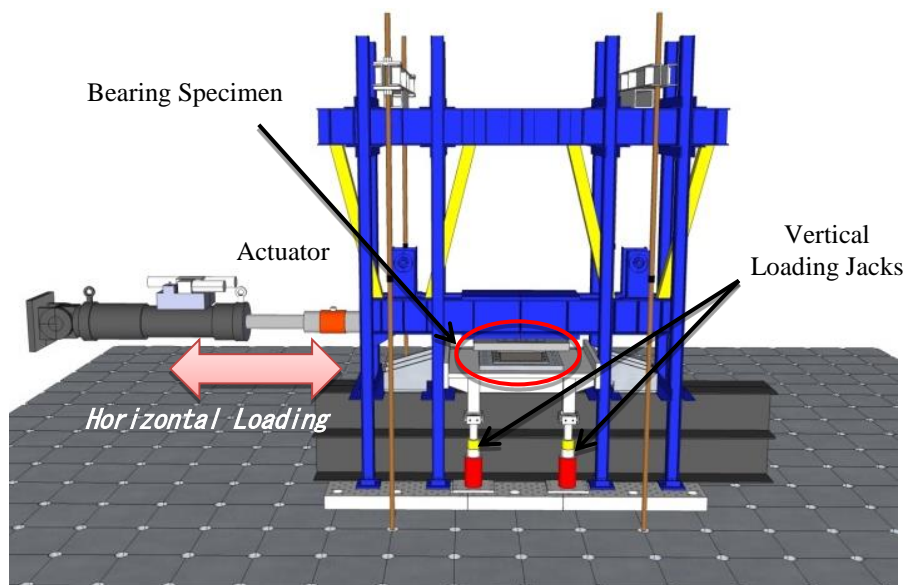
Figure 3.1 Loading test equipment

The test equipment used in the loading tests is shown in Figure 3.1. All tests are horizontal shearing loading tests under a constant vertical load corresponding to the dead load of the superstructure. The specimen is connected to a 200tf horizontal hydraulic actuator through a load beam constrained by the link mechanism attached to a rigid steel frame so as movement only in the horizontal direction is allowed during shear loading. At the same time, a constant vertical load of 563kN equivalent to the dead load reaction force was applied to the specimen using four 500kN vertical loading jacks and a bottom loading table constrained in the horizontal direction with stoppers.

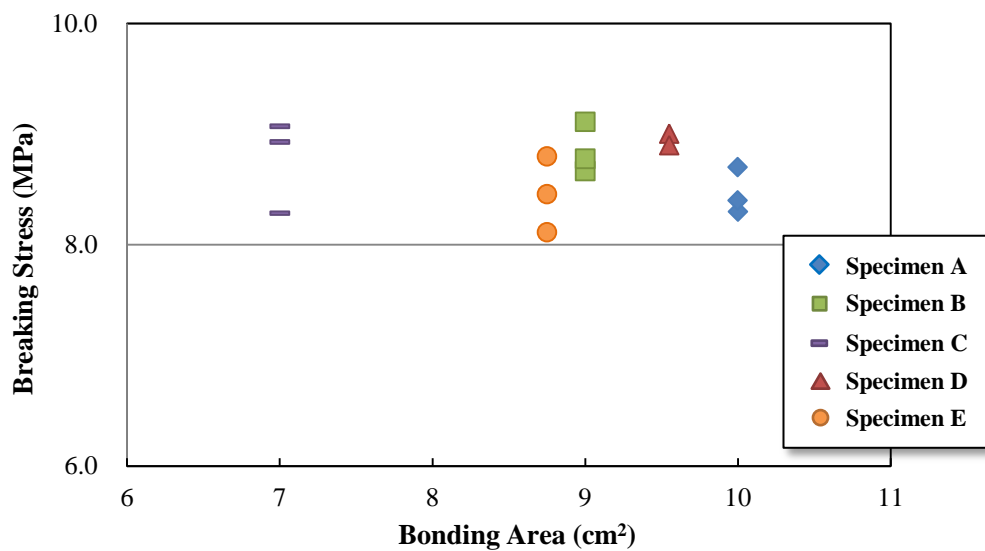
Figure 3.9 Results of lap shear tests

The difference of the failure stresses between the specimens is not significant. It is also noteworthy that the results of the specimen E are in the same range in spite of possible high stress concentration in the specimen E due to partly cutout. When a good bonding condition is ensured, the bonding between the steel plate and rubber is not regarded as a critical factor for the cause of rupture and failure of the bearing.

- From the result of the lap shear tests, it is found that a good bonding between the steel plate and rubber is not regarded as a critical factor for the cause of rupture and failure of the bearing.
