## FULL-SCALE EXPERIMENTAL SEISMIC COLLAPSE STUDY of a 4-STORY WOOD-FRAME BUILDING

**P. Bahmani<sup>1</sup>, J.W. van de Lindt<sup>2</sup>**

### ABSTRACT

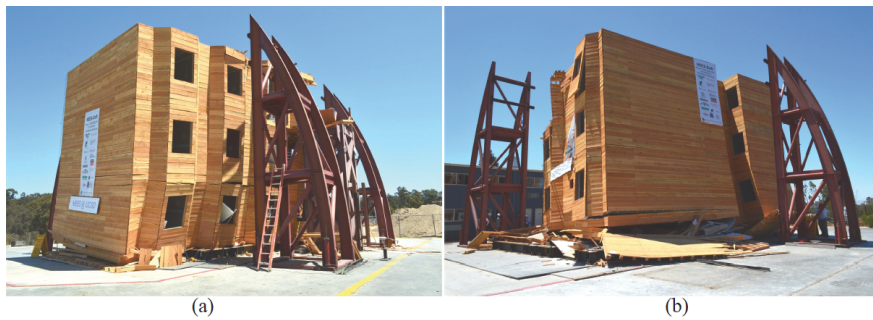
Fig 7: Photos of the collapsed building: (a) South-West view, and (b) North-East view.

The maximum ISD was about 95.9 mm (3.78 in.) and 102 mm (4.02 in.) with almost no observed residual drift for the Cape Mendocino and Loma Prieta ground motions scaled to MCE level, respectively. The building was damaged but not near collapse. The last three tests that led to collapse of the building were conducted by subjecting the building to the Superstition Hills ground motion. As shown in Figures 5(d) and 6(d), this ground motion has very high response spectral acceleration and displacement for periods larger than 1.0 sec. Furthermore, from Figure 6(a) it can be seen that the ground motion velocity and displacements of the Superstition Hills record are larger than those for the two other ground motions. From Figure 6(b), it can be seen that the building experienced very high translational displacement and rotational movement during these seismic tests. In fact, the building never even passed through its original equilibrium position further underscoring the severity of the damage sustained during the Superstition Hills shake. The building was then subjected to the same ground motion but this time with it again scaled to MCE intensity,  $S_a=1.8g$ , which led to collapse of the building. The shake table was stopped after the full collapse to protect the lab equipment rather than allow the collapsed building to potentially be damaged further. It can be seen from the last column in Figure 6(b) that the building experienced about 635.9 mm (25.0 in.) of translational displacement and about 11 degrees of rotational movement at the onset of collapse. Maximum displacements of 470 mm (18.5 in.) (i.e., ISD ratio= 19.3%) and residual displacements of about 350 mm (13.8 in.) (ISD ratio= 14.4%) when subjected to the first Superstition Hills earthquake were observed. The building had about 400 mm (15.7 in.) of residual displacement (i.e., ISD ratio= 16.4%) leaning toward the west at the start of the ground motion. Then, it moved slowly further to the west for the last time then moved toward the east and rotated about 11 degrees before hitting the safety towers. Since the maximum stroke of the string potentiometers was  $\pm 635$  mm ( $\pm 25$  inch), the last recorded displacement was 635.9 mm (25.0 in.), and after reaching this displacement the string potentiometers were. Figure 7 shows the photos of the collapsed building from different angles. It can be seen that the building rotated substantially before it collapsed and hit the safety towers at the south-east corner of the building. Also, the first story was completely destroyed as expected in a soft-story collapse mechanism.
